Case Report: FIU Pedestrian Bridge Collapse (Miami, 2018)

Baraa Elmoussa

Faculty of Science and Technology, Department of Mechanics, Université de Lille, Villeneuve-d'Ascq, France.

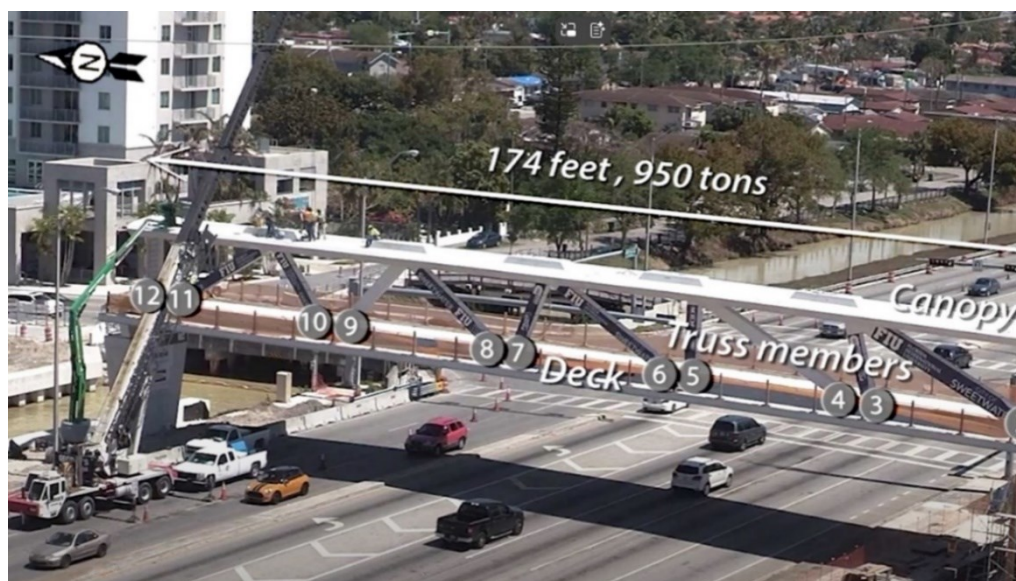
On March 15, 2018, at approximately 1:46 PM, the bridge, which was nearing completion, experienced a sudden and catastrophic failure. Earlier that day, workers were re-tensioning (tightening) the post-tensioned steel rods in one of the truss diagonals (member 11 at the north end of the span [Figure 2]) as part of remedial work to address cracking (Florida International University Pedestrian Bridge Collapse - Wikipedia, n.d.; National Transportation Safety Board, 2019). The nodal connection between diagonal member

11 and vertical member 12, which intersected the bridge deck at the north pier end, abruptly failed without prior indication (see Figure 2). According to the National Transportation Safety Board (NTSB) and Peng et al. (2019), eyewitnesses and a security video documented a loud bang or "whip crack," which was identified as the concrete at that node shattering. This incident involved a blowout of the concrete at the interface between members 11 and 12 and the deck. Instantly, the truss's geometry collapsed: the north end of the span dropped, and the entire 950-ton bridge span pancaked down

Figure 2. (a) Nodal Connections Between the Truss Members and the Deck (National Transportation Safety Board, 2019),

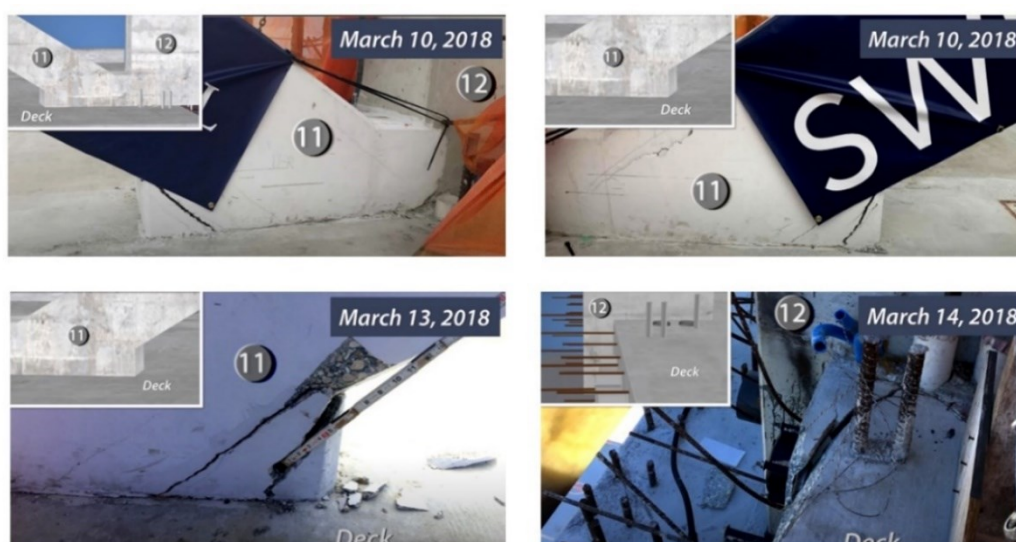
(b) Structural Damage Occurred at Joints 11 and 12 (National Transportation Safety Board, 2019).

critical decisions under dangerous construction conditions. The National Transportation Safety Board (NTSB) identified the primary cause of the failure as a critical error in the joint load calculations (connecting elements 11 and 12 with the deck) and the joint bearing capacity. This error was attributable to FIGG, the project's designer (National Transportation Safety Board, 2019). The loads the bridge would have to withstand were underestimated, while the design overestimated the horizontal shear capacity of the joint (National Transportation Safety Board, 2019; Shaver, 2021). A thorough analysis revealed that the joint had been subjected to excessive stresses since its partial construction, leading to the formation of internal weak zones that undermined the stability of the entire system. The absence of structural redundancy served to exacerbate the situation, as the absence of an alternative load-bearing path upon the failure of a node rendered

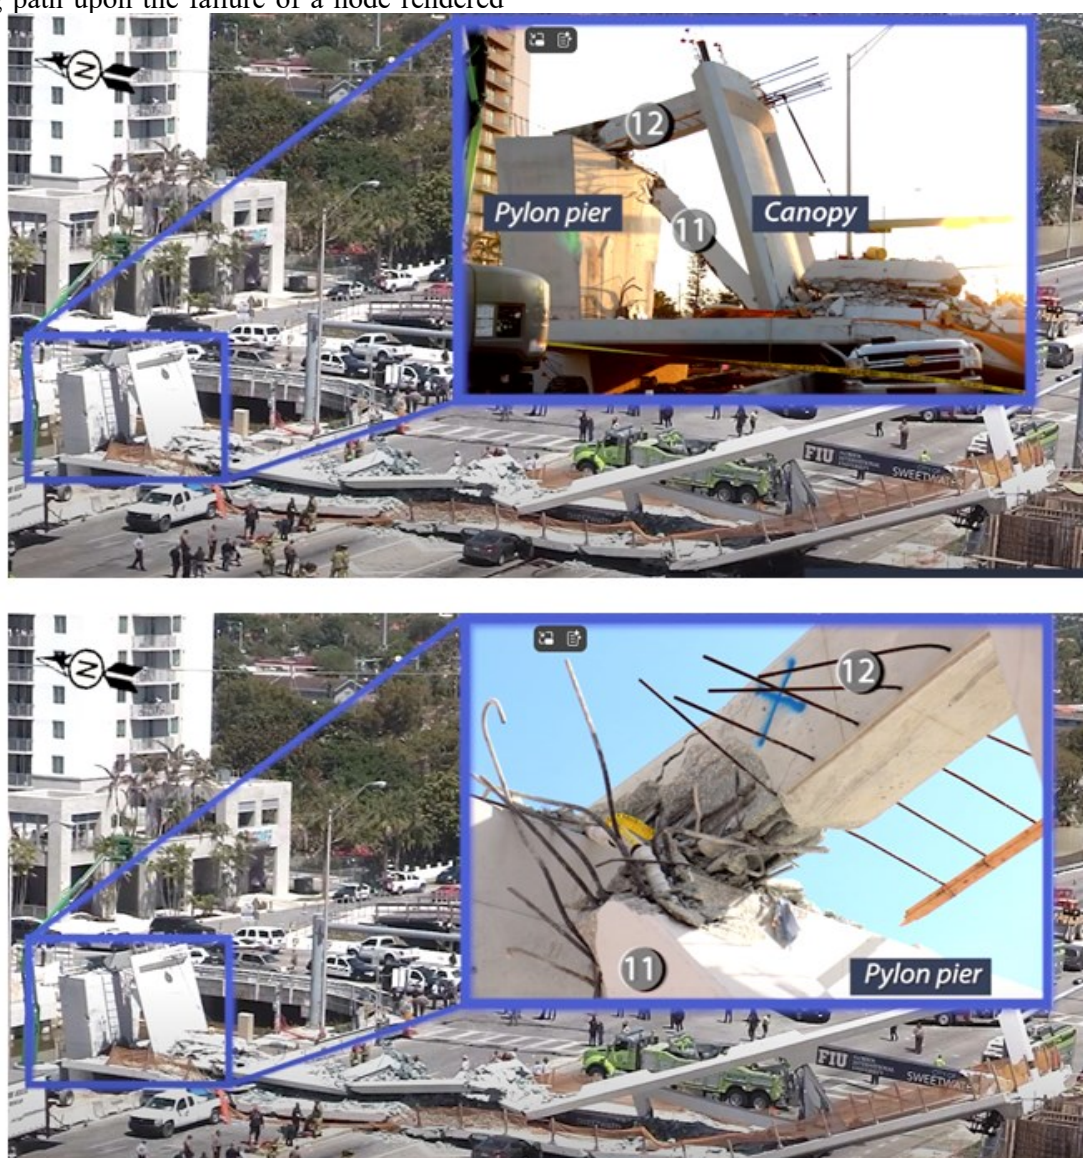
the collapse of Member 11 a direct cause of the collapse of the entire bridge (Florida International University Pedestrian Bridge Collapse - Wikipedia, n.d.; Management Philosophy Shifts | Professional and Career Topics, n.d.) (see Figure 3). The cold joint itself lacked the necessary structural details to provide sufficient roughness and effective shear friction. Furthermore, the drainage channel intersected with the member's reinforcement, further weakening the joint and causing it to fail under load (Management Philosophy Shifts | Professional and Career Topics, n.d.). The situation was further exacerbated by the implementation of a loosely coupled post-tensioning system, coupled with inadequate structural bonding, which diminished the node's capacity to resist cracking after the onset of cracking (Management Philosophy Shifts | Professional and Career Topics, n.d.).

Figure 3. Members 11 and 12 After the Collapse (National Transportation Safety Board, 2019).

Prior to the collapse, there were indications of potential failure, as evidenced by the emergence of substantial cracks in Member 11 and the surrounding
