Sustainable Restoration Techniques for Historic Buildings in Tyre City

Cite This Article: Awad, Z. (2023). Sustainable Restoration Techniques for Historic Buildings in Tyre City. *Steps For Civil, Constructions and Environmental Engineering*, 1(1), 14–23.

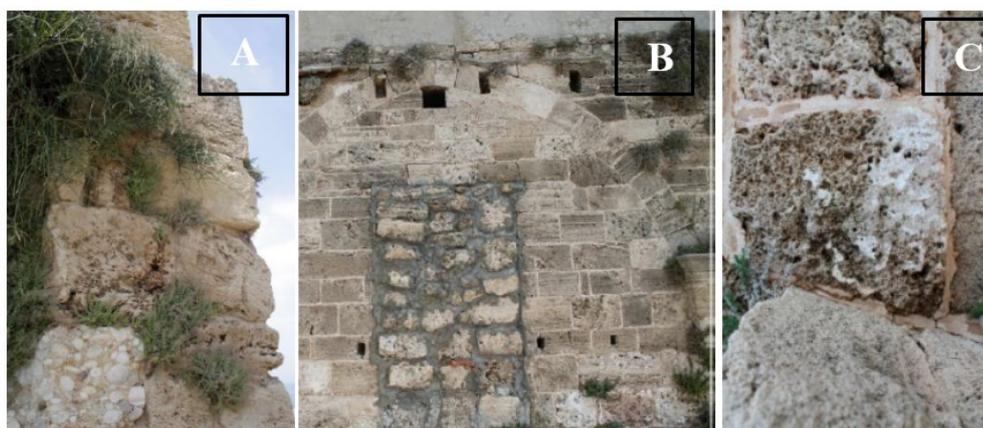
Figure 2. Images Taken at Site in Tyre City Showing Structural and Physical Changes (Problems). (A): Spread of Plants; (B): Appearance of Cements Sheets on Main Elevations; (C): Masonry and Stone Problems (Appearance of Black Colors, Bacteria, Holes...) (Source: Author)

In the old city of Tyre, Lebanon, there are numerous historic buildings, especially residential ones, which have endured for centuries. However, natural and environmental factors, as well as human activity, have caused deterioration over time. The following problems have been observed (**Figure 2**):

- Appearance of Cement Sheets on Main Elevations: Some buildings' stones have been renovated using cement to fill gaps.

- Drainage Pipes on Main Elevations: Modern drainage installations have been added to the main elevations, affecting the original appearance.
- Destruction of Some Balconies or Railings: Balconies and stairs of historic buildings have been damaged or removed.
- Cracks in Brick Roofs: Brick roofs have developed cracks, potentially compromising their structural integrity.
- Damages to Glass and Wood Openings: Glass and wooden openings, such as windows and doors, have suffered damages over time.
- Spread of Plants: Plants have grown on the walls due to frequent exposure to weather factors and water penetration between joints.
- Masonry and Stone Problems: Issues such as the appearance of black colors, bacterial growth, and holes in the masonry and stones have been observed.

The problems and reasons for plants growing on the walls are due to frequent exposure to weather factors (such as salt-laden winds and temperature differences near the sea) and the loss of mortar between the joints, which allows water to penetrate and create a suitable space for plant growth. As a result, maintenance involves uprooting and using chemical methods to eliminate these plants (**Table 1**).

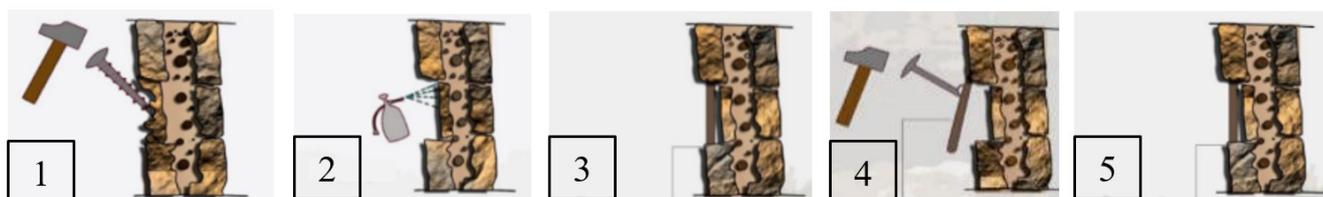
Figure 3. Diagrams Illustrating the Techniques for Preserving the Stone. (Source: Author)

Like other materials, stone is also exposed to various factors that can cause damage, such as the separation of its constituent layers. Therefore, it is essential to polish and repair the main surface of the stone. The benefits of using this method lie in preserving the largest quantity of the stone's main substance. The repair process involves the following steps:

- Outline the surface that requires repair and prepare the lime mortar.
- Spray the surface with water, then apply a second layer of clay until it exceeds the surface of the gap. Allow it to dry.
- Cover the finished surface with a damp piece of cotton and leave it to dry slowly.
- Trim flat surfaces with a saw blade according to their final shape. Then, carve out the marked surface with a chisel and hammer to obtain a uniform recess of 15 cm in depth.
- Hydrate the surface with water and use trowels to extend the plaster, filling half of the gap. Leave the plaster to dry for two or three days.

By following these steps, the main surface of the stone can be effectively repaired, preserving its original substance and enhancing its durability (**Figure 3**).

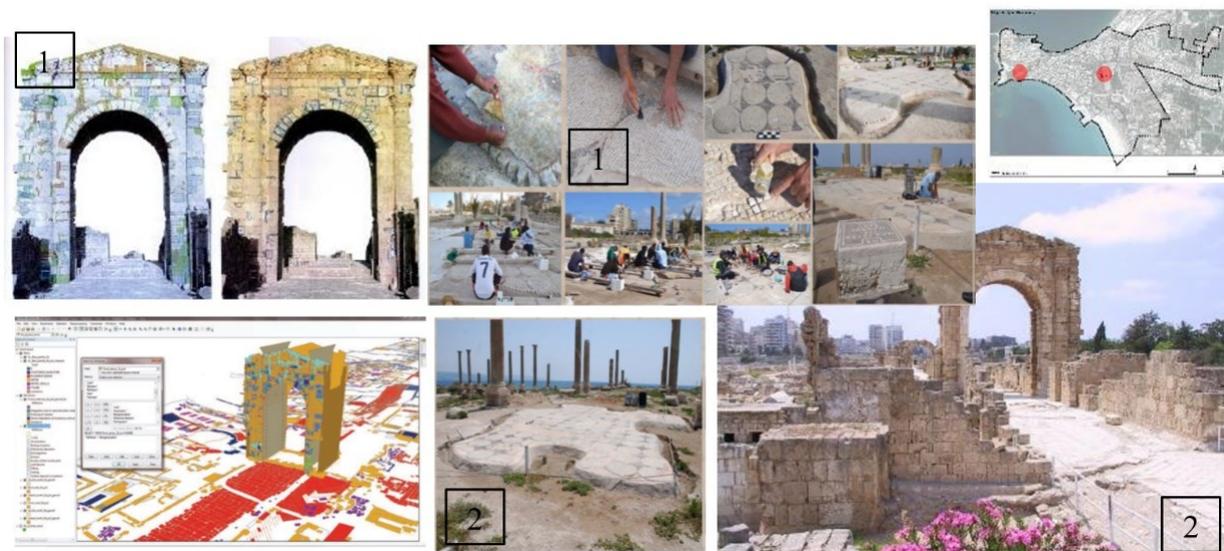
Figure 4. Before (as shown in images №1) and After (as shown in images №2) Restoration of the Archaeological Site in Tyre City on Site Work (Source: Edited by Author based on Badde & MacKinnon, 2016)

An illustrative example of the intervention conducted in 2014-2015 focused on a 69 sq.m area of the mosaic, within the framework of the Ba'albek and Tyre Archaeological Project (BTAP I), as shown in **Figure 4** images № 1. The intervention served as an opportunity to train local building technicians and youth in the principles and techniques of mosaic conservation-restoration. It commenced with condition reporting, topographic survey, photo documentation, and digital mapping, followed by foil mapping of gridlines and lacunae, mapping of past repairs, and mortar sampling. The restoration process involved lifting the mosaic in sections, along with the top half of the cement substrates, and then removing the cement to clean the tesserae. The mosaic was then relocated in situ on a new hydraulic lime mortar substrate (Badde & MacKinnon, 2016).

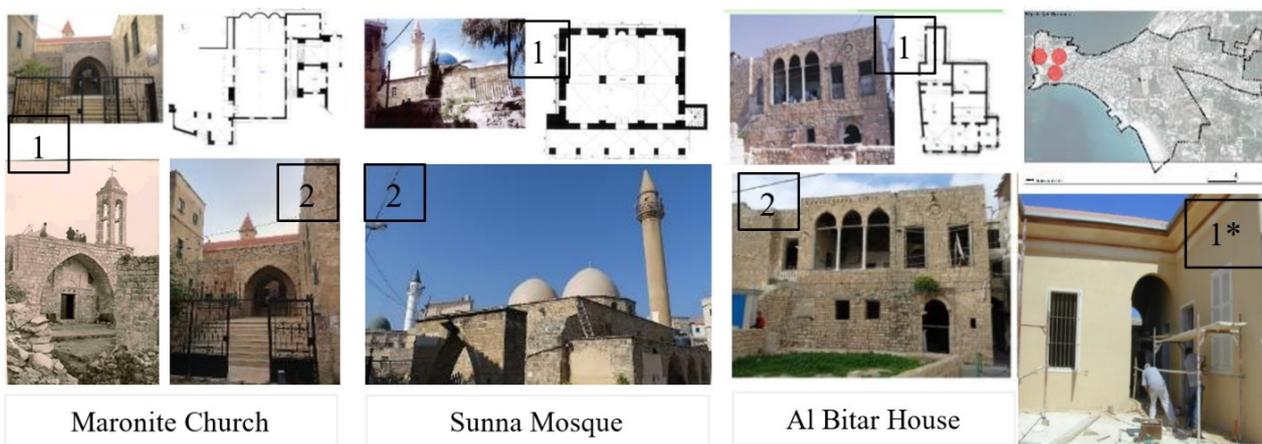
Figure 5. Historic Buildings in the Old City Before (as shown in images №1/№1*) and After (as shown in images №2) Intervention. (Source: Based on khoury study 2002; photos taken by the Author 2022-2023)

historic buildings, including commercial, residential, religious, and cultural structures, often involved a combination of technical and structural methods. Traditional building techniques and locally-sourced materials, such as sandstone, were utilized to ensure the preservation of the buildings' original appearance.

Local artisans (as shown in **Figure 5**, Image №1*) played a significant role in the intervention process. Their expertise and craftsmanship were employed in the restoration of the Al Mamluk Palace, renovation of the Maronite Church, restoration of the Sunna Mosque and Sharaf Eddine Mosque, and the conservation of AL Bitar House, among other projects. The involvement of these skilled artisans contributed to the authenticity and cultural continuity of the restoration efforts.

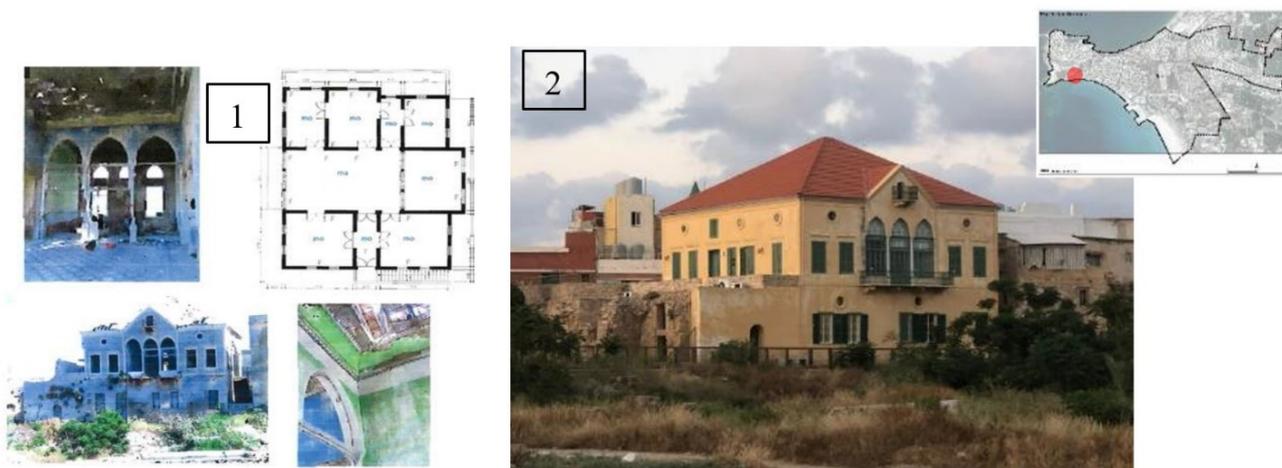
Figure 6. Mamluk Palace Before (as shown in images №1) and After (as shown in images №2) Intervention. (Source: Based on khoury study 2002, photo taken by the Author 2023)

Mamlouk Palace: The Mamlouk Palace, constructed in the 13th century and located adjacent to the main archaeological site of the old city of Tyre, underwent extensive restoration. The restoration process involved repairing the damaged walls and roofs, reinforcing the foundations, and carefully preserving the original decorative elements (as seen in **Figure 6**, Images №1). Simultaneously, modern amenities were integrated into the building while ensuring the preservation of its historical and cultural significance.

One of the major challenges faced by the engineers during the restoration was replacing the damaged wooden beams and columns without compromising the integrity of the original stonework. To address this, they conducted a meticulous approach by cautiously removing the damaged elements and substituting them with new, durable, and sustainable materials. In this regard, the decision was made to remove the entire roof of the second floor and replace it with a roof composed of trusses, eliminating the use of wood (Concrete casting for the new slab). Additionally, the foundations of the building, which had weakened over years of neglect, required extensive reinforcement to ensure the structure's stability and longevity.

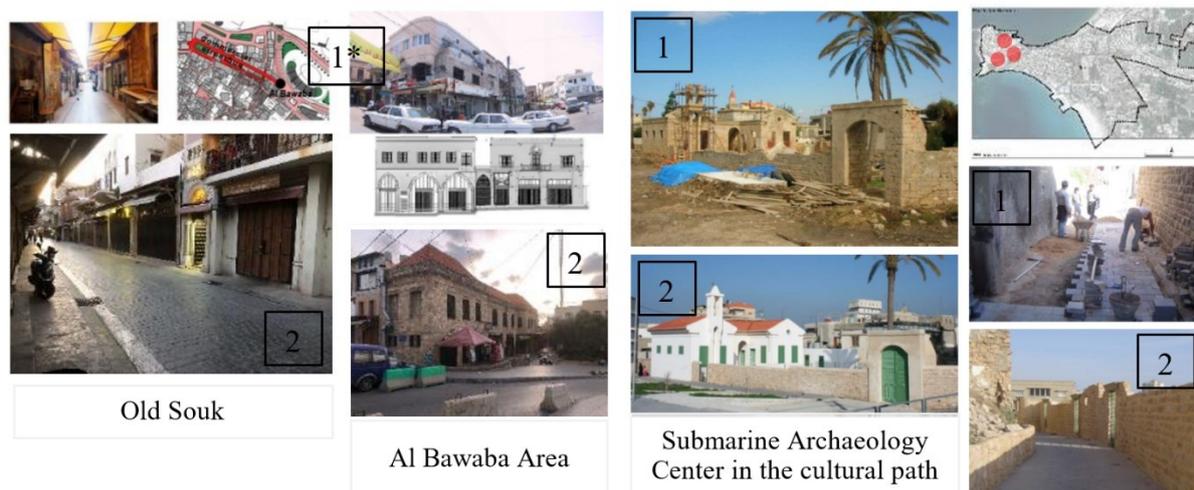
Figure 7. Cultural Path, Old Souk and Al Bawaba Before (as shown in images №1/№1*) and After (as shown in images №2) Intervention.

Restoration work was executed in a technical and structural manner, employing traditional techniques and materials to maintain the authentic appearance of the buildings (as depicted in Figure 7, Images №1). To ensure the safety of inhabitants, the restoration team also utilized modern techniques to reinforce the structures. For example, some buildings had their foundations and walls reinforced with steel and concrete to enhance earthquake resistance.

Incorporating innovative technologies, the CHUD project employed Building Information Modeling (BIM) and Geographic Information System (GIS). BIM facilitated the creation of accurate 3D models of the buildings, allowing the restoration team to identify any structural or design flaws before commencing restoration work. On the other hand, GIS was utilized to map the buildings and determine the most suitable sites for the project, considering factors such as accessibility and existing infrastructure (as shown in **Figure 7**, Images №1*).
