**Research Article**

# **An Integrated Framework for the Rehabilitation of War-Damaged Public Buildings using BIM, AI, VR, and AR Technologies**

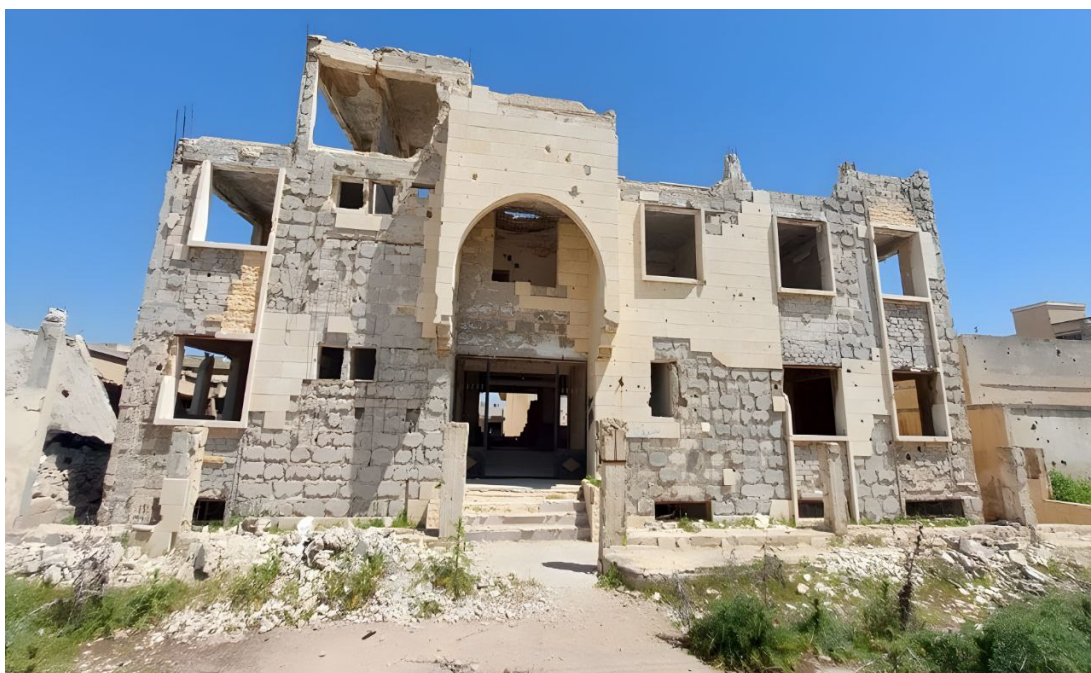
**Figure 2.** The Front Elevation of the Building.

As illustrated in **Figure 2**, the subject of this study is an agricultural bank located in the city of Souran in Hama.

The Agricultural Bank in Souran consists of three stories, a basement, and a roof totaling 345 square meters. This building served as the case study for this application of the steps. The building was used for operations beginning in the 1990s.

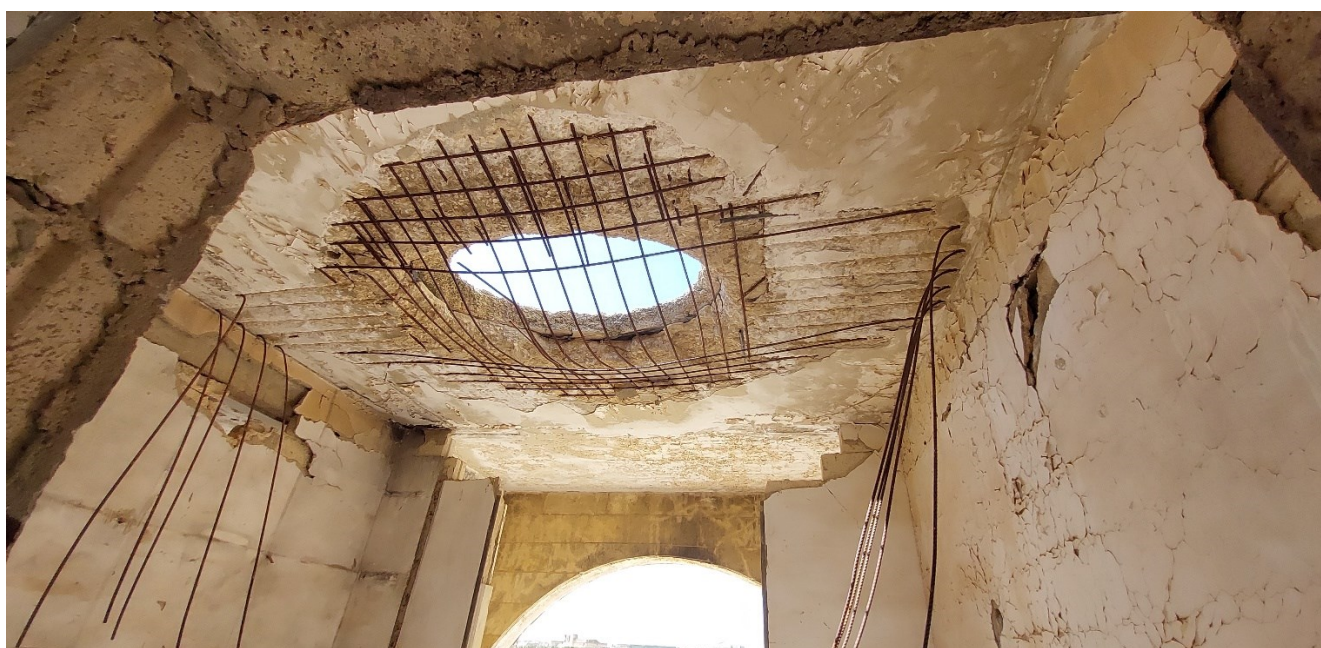
**Figure 4.** Structural Damage in the First-Floor Slab Showing Large Openings and Exposed Reinforcement

As illustrated in **Figure 4**, the war-damaged buildings exhibited substantial structural degradation.

Description: The investigation revealed that the ceiling had sustained a series of openings of varying dimensions, resulting from the direct impact on the first-floor slab. It is noteworthy that a number of the apertures exhibited dimensions exceeding one meter in width. As demonstrated in Figure 4: The separation of the concrete cover from the reinforcement resulted in the severing and bending of the reinforcing steel. Subsequent to this, the exposed steel underwent a process of corrosion and alterations to its cross-sectional characteristics due to its exposure to the environment.

The first method is upper slab casting for reinforcement above the current slab. This technique is employed for the purpose of reinforcing the slabs of the final floor or for strengthening the building's slabs prior to completion. According to engineering requirements, the implementation of such reinforcement measures results in a reduction of floor height, thereby influencing door heights and the measurements necessary for kitchen and bathroom installations.

The second method involves the implementation of slab reinforcement exclusively at the apertures.

The slab reinforcement process is initiated with the temporary shoring of the slabs, thereby relieving them of their weight. Subsequent to this procedure, the damaged steel is excised, and the extant reinforcement is meticulously cleaned. Subsequently, new reinforcement bars of an equivalent diameter are installed, ensuring a secure connection between the existing and new bars. In order to protect the steel and bond the concrete surfaces, the reinforcement bars are treated with an anti-rust epoxy, and a medium-viscosity epoxy coating is applied to seal the interface between the old and new concrete. Subsequent to this, formwork is installed by drilling holes into the ceiling, and grout is cast to complete the repair. Grout is selected over cement mortar due to its minimal shrinkage, which is critical for preventing the failure of the composite

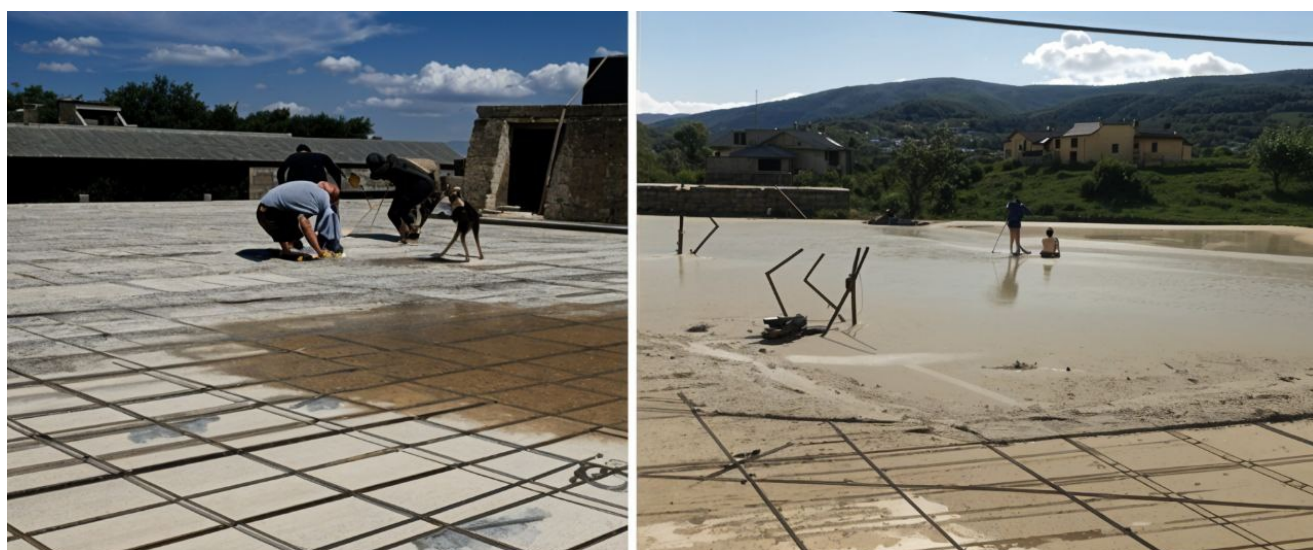
**Figure 5.** Upper Slab Strengthening Procedure Adopted for Reinforcing the Damaged Floor System

The following methodology is proposed for the remediation of the roof, as illustrated in **Figure 5**.

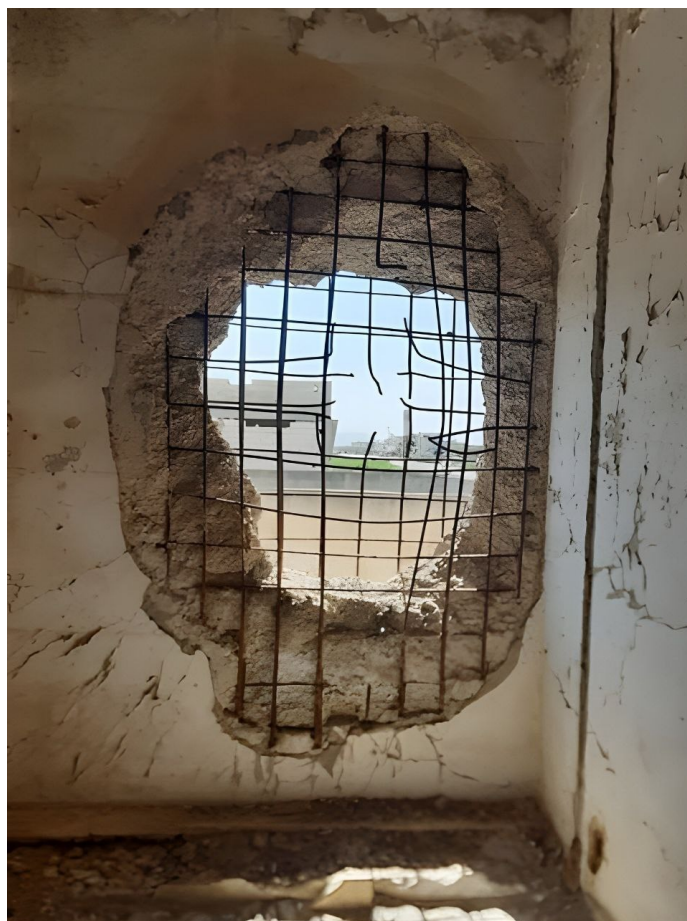
**Figure 6.** Severe Damage in the Load-Bearing Wall Caused by Direct Impact

Description: A direct shell hit has caused a break in the load-bearing wall's body within the building, showing significant structural deterioration (**Figure. 6**).

The procedure for repairing a wall entails the initial step of providing temporary support to the surrounding region, thereby alleviating the load on the damaged wall. Subsequently, all concrete in the damaged section

of the wall is removed. The damaged reinforcement is excised with a saw and substituted with new reinforcement that is welded to the original steel in a manner appropriate for the specific conditions. The formwork is constructed according to the revised wall dimensions, and the concrete is poured either in phases or by drilling holes in the ceiling and filling them with concrete mixture. Following a thorough examination of the affected area and the compilation of data that was either missing or altered due to the damage, blueprints are manually created to document the current state and guide the repair process. As demonstrated in **Figure 7**, the procedure for creating apertures in the ceiling for the purpose of concrete pouring is illustrated.

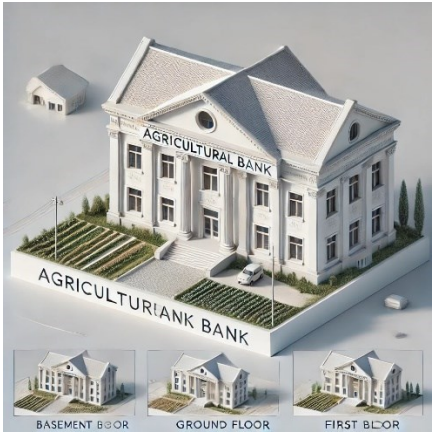
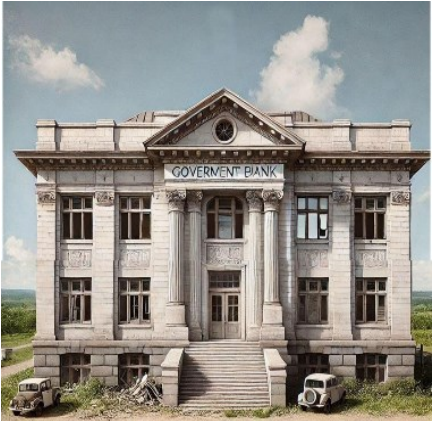
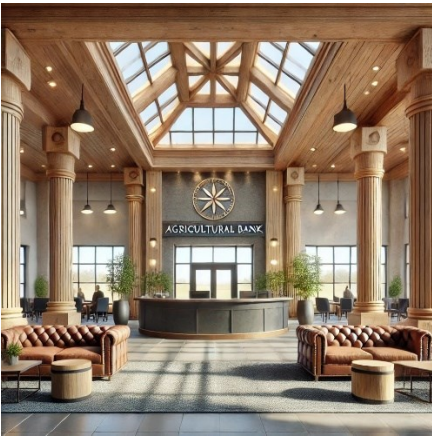
Table 4. AI prompt Descriptions Used for Generating Post-Restoration Design Alternatives.

| Description | AI Prompt |
|---|---|
| I would like a visual representation of this building, ensuring that the exterior structure, including the number of windows and doors, is accurately depicted. Please avoid excessive architectural decorations as the building is a government facility functioning as a rural agricultural bank. I would like the front façade to be clad in white stone with a simple design that complements the rural environment. The building consists of a basement, a ground floor, and a first floor, with a total area of 345 square meters | |
| Place two columns in front of the main entrance to draw the tention of clients to the door and give the building a strong architectural identity. Ensure that the architectural decorations are not excessive, as I want it to lean towards simplicity since it is a government building. | |
| Can you show me images from inside the building using realistic materials? | |
| I want to see this design from different angels | |

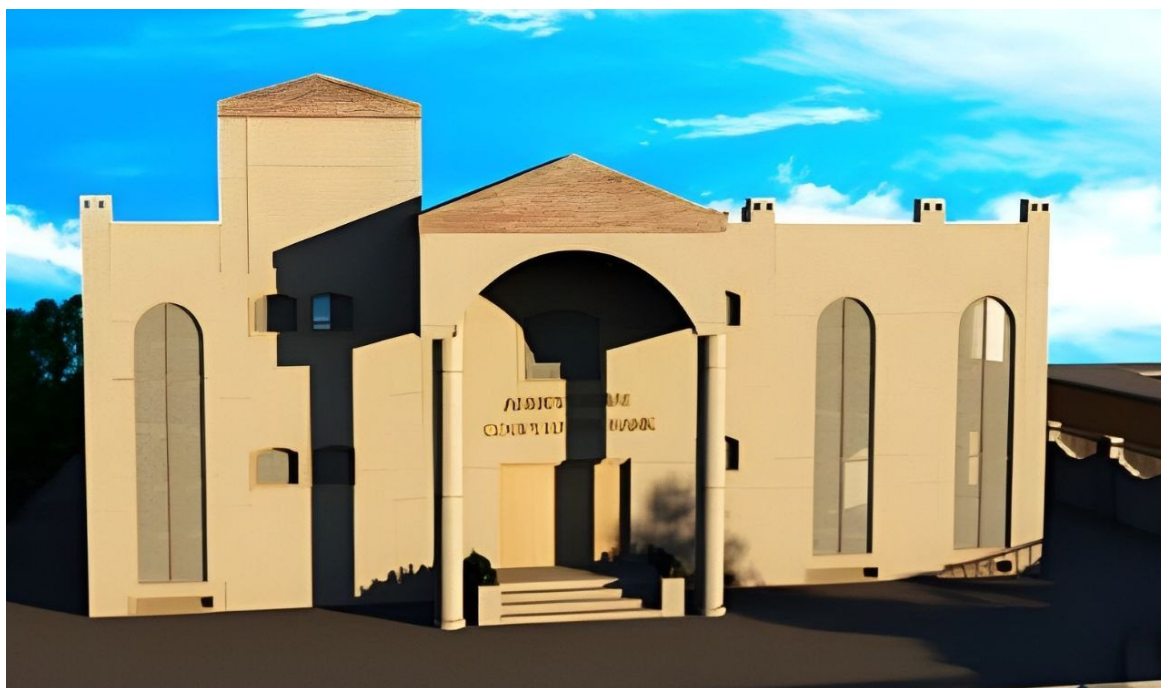
**Figure 11.** First Proposed Architectural Design Alternative for the Rehabilitated Building.

Two design alternatives were proposed for the Agricultural Bank, with the first alternative featuring the following advantages:

- The presence of continuous windows between floors, extending across walls, is a notable architectural feature. The design is characterized by its emphasis on transparency, contributing to an overall integration with the external environment. The implementation of this design feature enables enhanced natural light diffusion and optimizes building ventilation, thereby promoting enhanced energy efficiency within the constructed environment.
- The primary entrance is characterized by the presence of circular columns. The architectural design of the building was intended to convey a sense of formality, thereby underscoring its function as a government edifice. This design feature served to direct the attention of potential clients towards the designated

entrance, thus facilitating the smooth flow of traffic and ensuring the security of the premises.

As illustrated in **Figure 11**, the initial alternative that displays these modifications is presented.

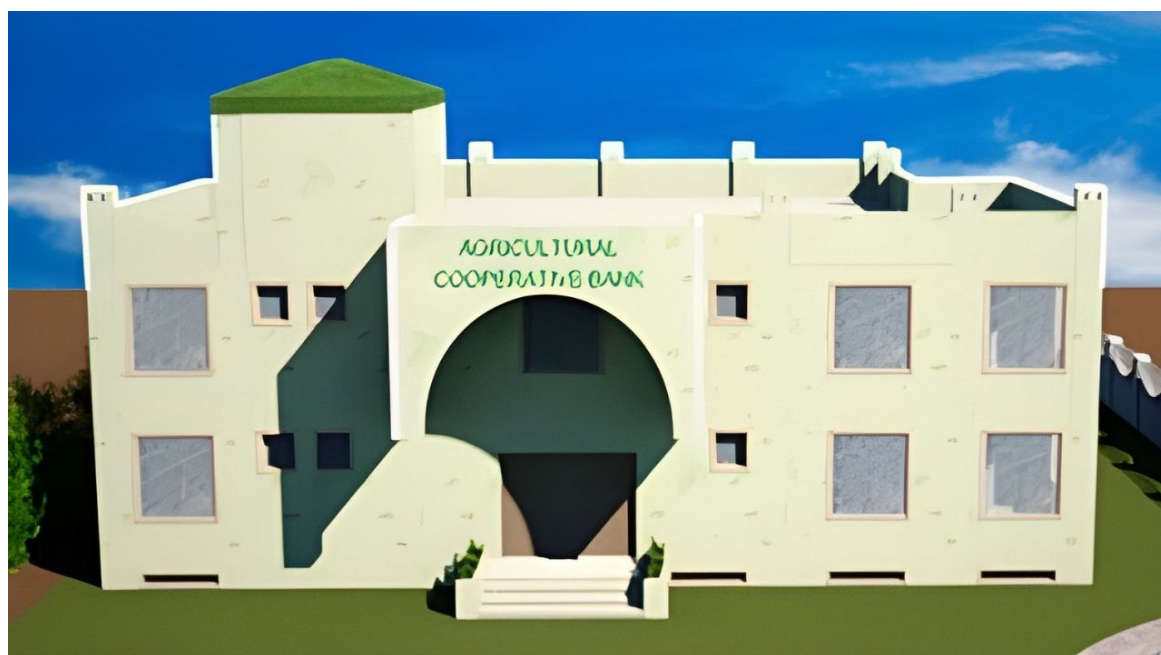
**Figure 12.** Second Proposed Architectural Design Alternative for the Rehabilitated Building.

With regard to the second alternative: (Separate windows):

- The aforementioned observations suggested that each floor of the building is designed to serve a distinct purpose and regulate the distribution of interior light.
- A modification of the exterior and interior cladding is indicated. This approach was undertaken to imbue the edifice with an identity that reflects its function as an Agricultural Bank, thereby creating a cohesive impression on the community and the surrounding environment. The objective was to establish a visual identity that contributes to the building's recognition.

As illustrated in **Figure 12**, the second alternative that demonstrates these modifications is presented.

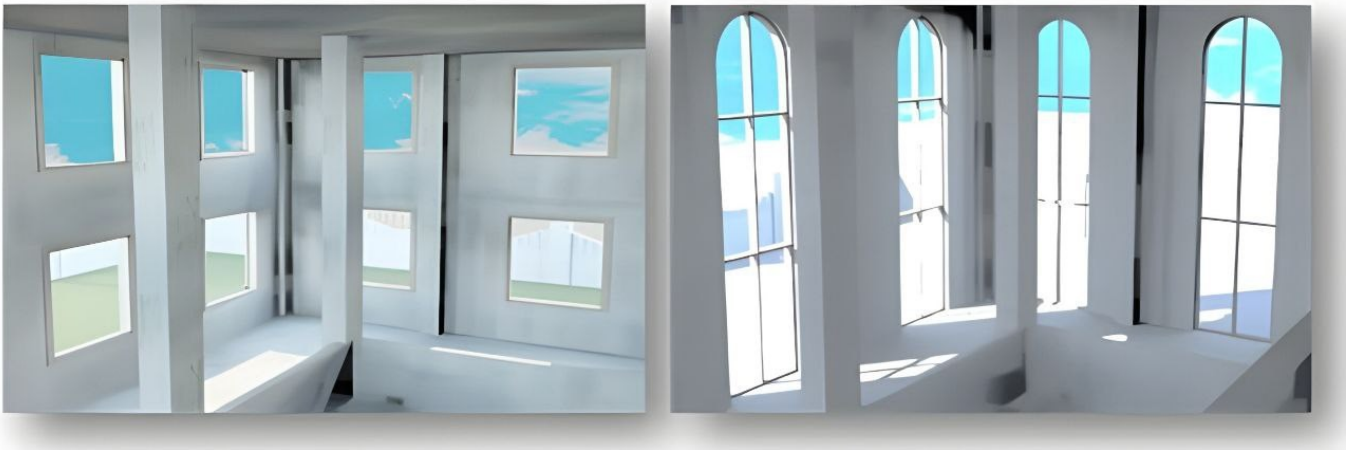
**Figure 13.** Comparison of Interior Daylight Distribution Between the Two Design Alternatives.

In this section, illustrative images are presented that demonstrate the disparity in light distribution between the two alternatives. **Figure 13** provides a visual demonstration of methods for modifying windows to regulate building lighting.
